Preliminary Arborist Report

**11 El Camino Real
San Carlos, CA**

December 2022
Revised March 2023

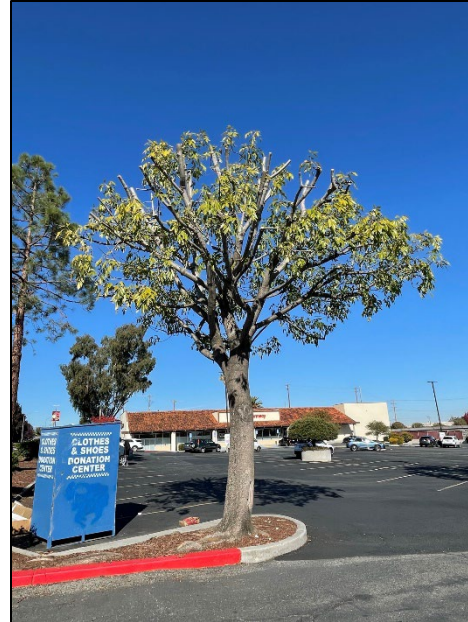
Evergreen ashes #135 and 137 were in fair condition, and #134 was in good condition. Ash #135 and 137 had been recently topped (Photo 1). Ash #134 was in good condition with vigorous foliage. Trunk diameters ranged from 8 to 19 inches with an average of 14 inches.

Photo 1. Ash #137 had been recently topped and was growing in landscape bulb-out.

137	Evergreen ash	16	Yes	3	Low	Remove	Large surface roots; trunk wound east; multiple attachments at 8'; recently topped.
138	Canary Island pine	20	Yes	3	Low	Remove	Low live crown ratio; good upright structure; surface roots; healthy crown.
139	Canary Island pine	16	Yes	3	Low	Remove	Low live crown ratio; good upright structure; suppressed east; surface roots; thin canopy.
140	Southern live oak	8	No	4	Moderate	Remove	In raised planter; can't see root flare; multiple attachments at 4'; full healthy crown.
141	Southern live oak	6	No	3	Moderate	Remove	In raised planter; can't see root flare; multiple attachments at 5'; small twig dieback; slightly thin crown.
142	Evergreen pear	8	No	4	Moderate	Remove	Multiple attachments at 5'; small twig dieback; healthy crown.
143	Chinese pistache	11	Yes	4	Moderate	Remove	Codominant trunks arise from 1'; narrow union; small twig dieback; healthy canopy.
144	River red gum	45	No	3	Low	Remove	Multiple large attachments at 7'; history of large branch failure; topped; weakly attached epicormic growth; small twig and branch dieback.

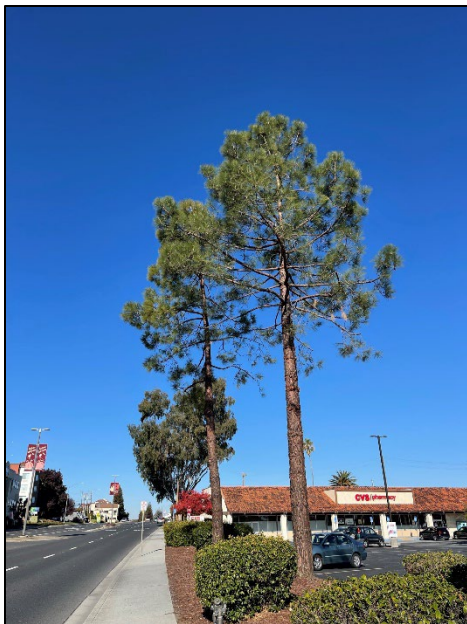
- Red river gums #144 and 145 were located between El Camino Real and the CVS building. The condition of #144 was fair with a trunk diameter of 45 inches while gum #145 had a 16-inch diameter and was in poor condition. Both trees had large branches arising from 7 – 8 feet.
- Tulip trees #132 and 133 were in fair condition and had diameters of 10 and 7 inches. Both were in parking lot planters and had limited root zones. Twig dieback was evident in both trees.
- Canary Island pine #138 was in fair condition with a trunk diameter of 20 inches. Pine #139 was also in fair condition with a trunk diameter of 16 inches. Both trees had low live crown ratio and the lower branches had been removed up to 15 feet (Photo 2).

Photo 2. Canary Island pines #138 in the foreground and #139 (behind and to left), had low live crown ratio.

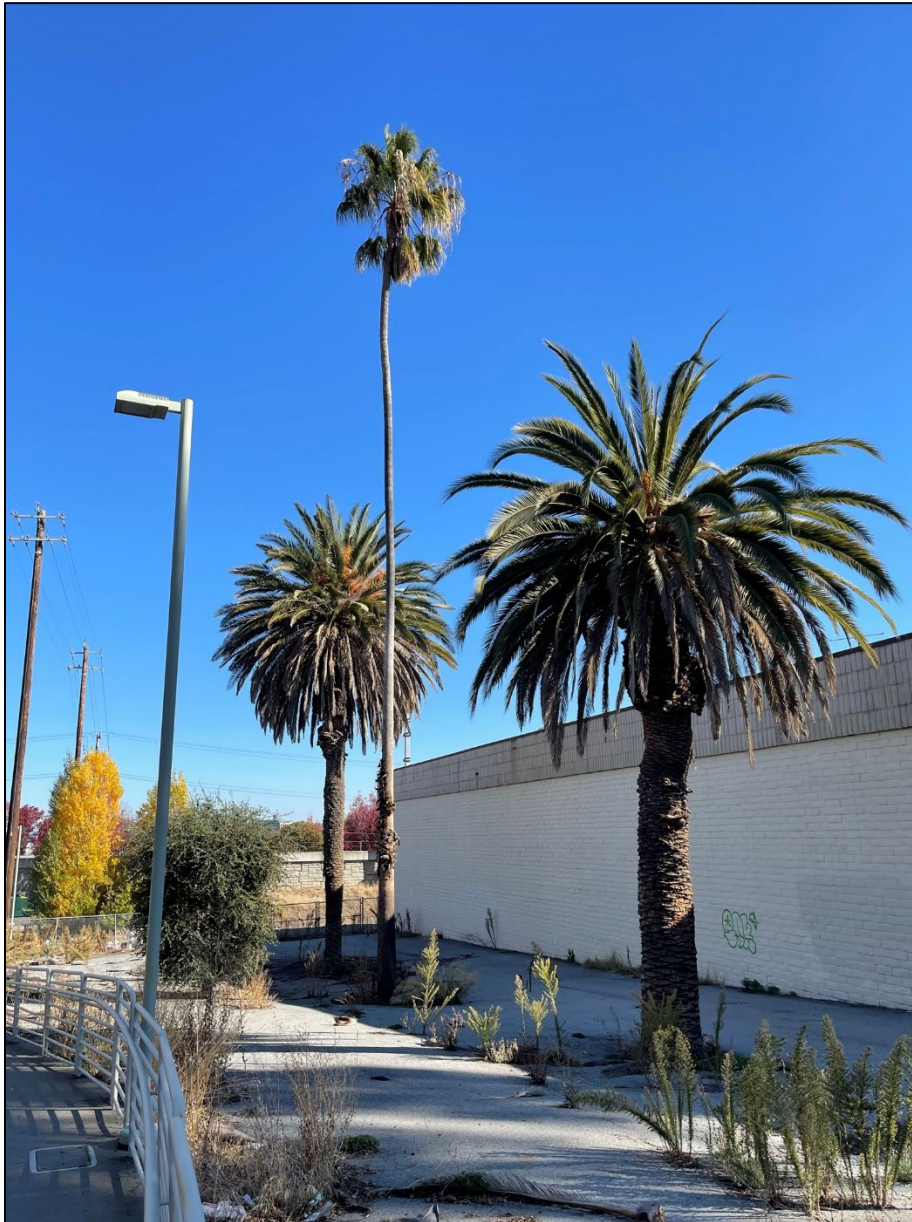
- Off-site Canary Island date palms #146 and 148 were located to the rear of the CVS building and were surrounded by asphalt (Photo 3, next page). Both palms were in good condition; both had a trunk diameter of 28 inches.

- Evergreen pear #142 had a trunk diameter of 8 inches and was in good condition. This tree had a full canopy with moderate vigor.
- Off-site Coast live oak #149 had a trunk diameter of 8 inches and was in good condition (Photo 3). The tree was surrounded by asphalt with a natural form and a full vigorous crown.
- Off-site Mexican fan palm #147 was in good condition and had a trunk diameter of 17 inches (Photo 3). This tree was also surrounded by asphalt behind the CVS.

Photo 3. Mexican fan palm #147 was growing between Canary Island date palms #146 and 148. Coast live oak #149 is just to the left of fan palm #147.

145	River red gum	16	No	2	Low	Remove	Multiple large attachments at 8'; trunk decay; significant twig and branch dieback; sparse canopy.
146	Canary Island date palm	28	No	4	Moderate	Preserve	Off-site. Brown trunk 20'; fire damage on lower trunk; healthy canopy.
147	Mexican fan palm	17	No	4	Moderate	Preserve	Off-site. Brown trunk 60'; healthy canopy.

Tree No.	Species	Trunk Diameter (in.)	Protected Tree?	Condition 1=poor 5=excellent	Suitability for Preservation	Preliminary Disposition	Comments
148	Canary Island date palm	28	No	4	Moderate	Preserve	Off-site. Brown trunk 30'; healthy canopy.
149	Coast live oak	8	No	5	High	Preserve	Off-site. Natural form; full healthy canopy.

Canary Island date palms #146 and 148, Mexican fan palm #147 and coast live oak #148 are off-site to the northwest of the property line. I recommend preservation of these four trees (none of which have *Protected status*). Successful retention of these trees is predicated on adherence to the **Preliminary Tree Preservation Guidelines**.
