Prepared for **SummerHill Apartment Communities**

**PRELIMINARY GEOTECHNICAL INVESTIGATION
PROPOSED RESIDENTIAL BUILDING
11 EL CAMINO REAL
SAN CARLOS, CALIFORNIA**

January 5, 2023
Project No. 21-2014

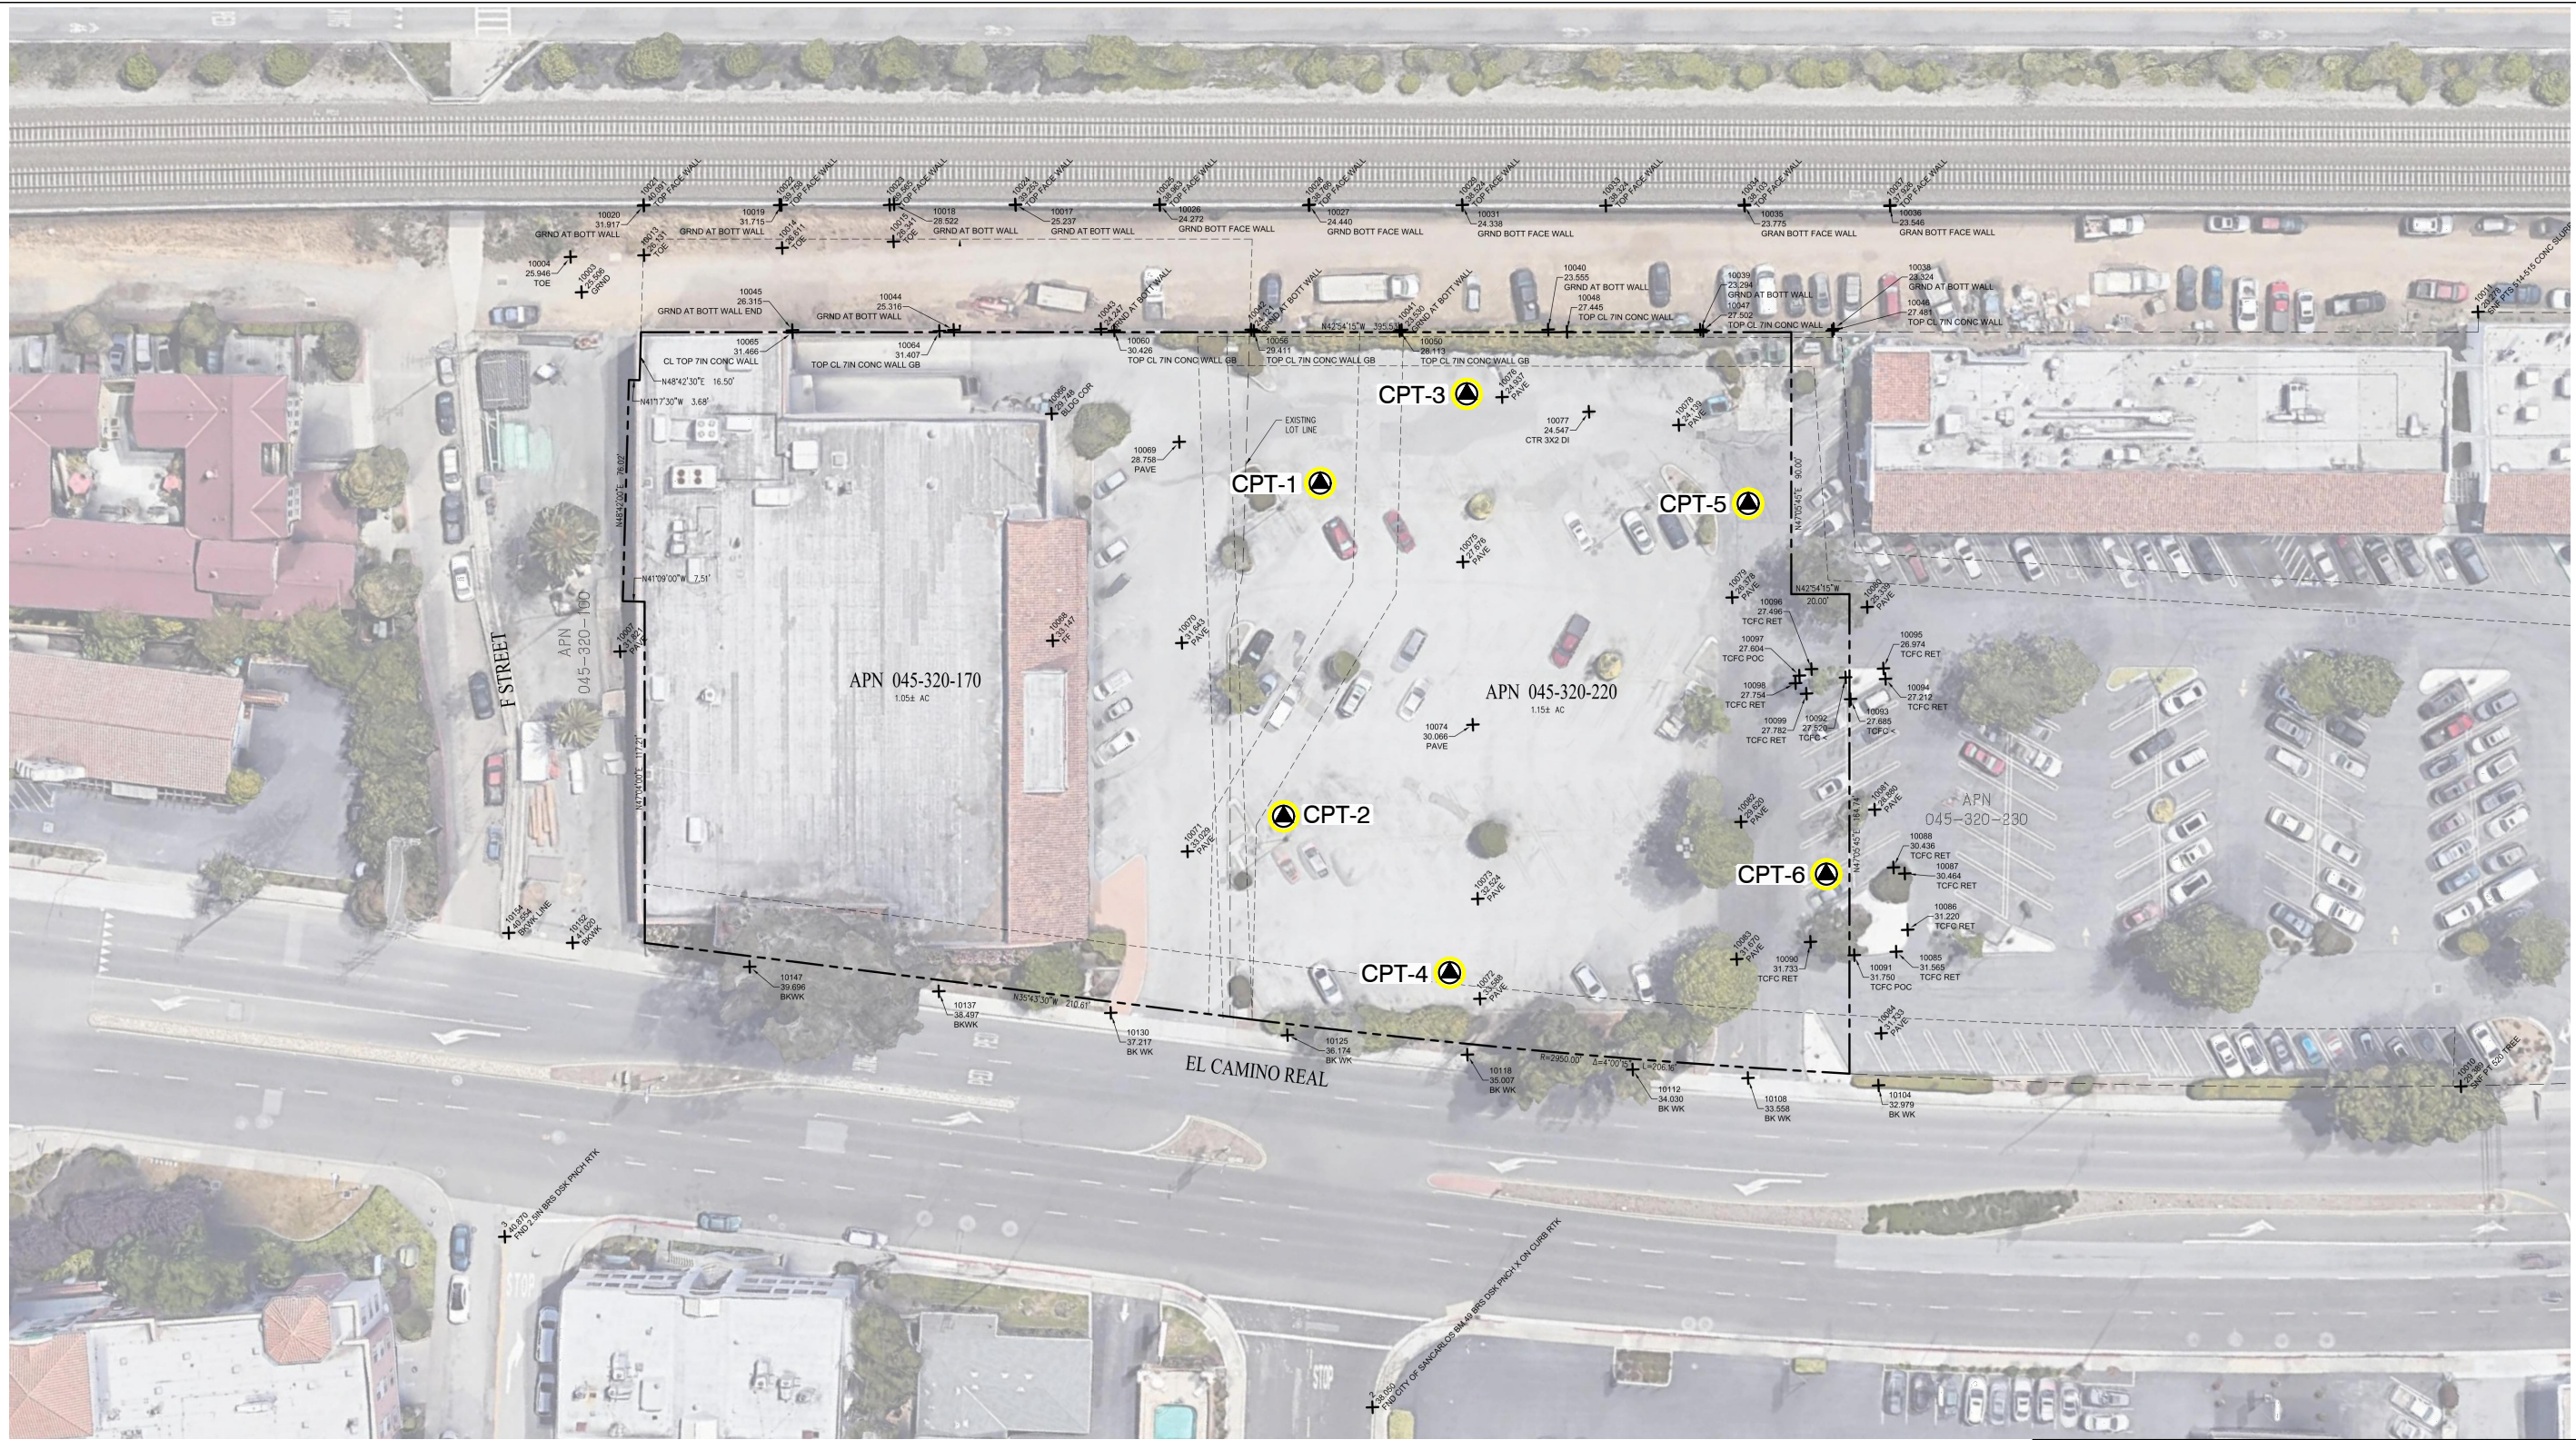
Date 05/07/21 | Project No. 21-2014 | Figure 2

CPT-1

Our field investigation consisted of performing six CPTs, designated as CPT-1 through CPT-6, at the approximate locations shown on the Site Plan, Figure 2. Prior to performing our field investigation, we submitted a drilling notification form to San Mateo County Environmental Health Services Division (SMCEH). We also contacted Underground Service Alert (USA) to notify them of our work and retained a private utility locator, Precision Locating, LLC, to verify the CPT locations were clear of existing underground utilities.
